February 2001

Lower Granite Dam

Radial Gate Inspection and Testing

US Army Corps of Engineers, Walla Walla District

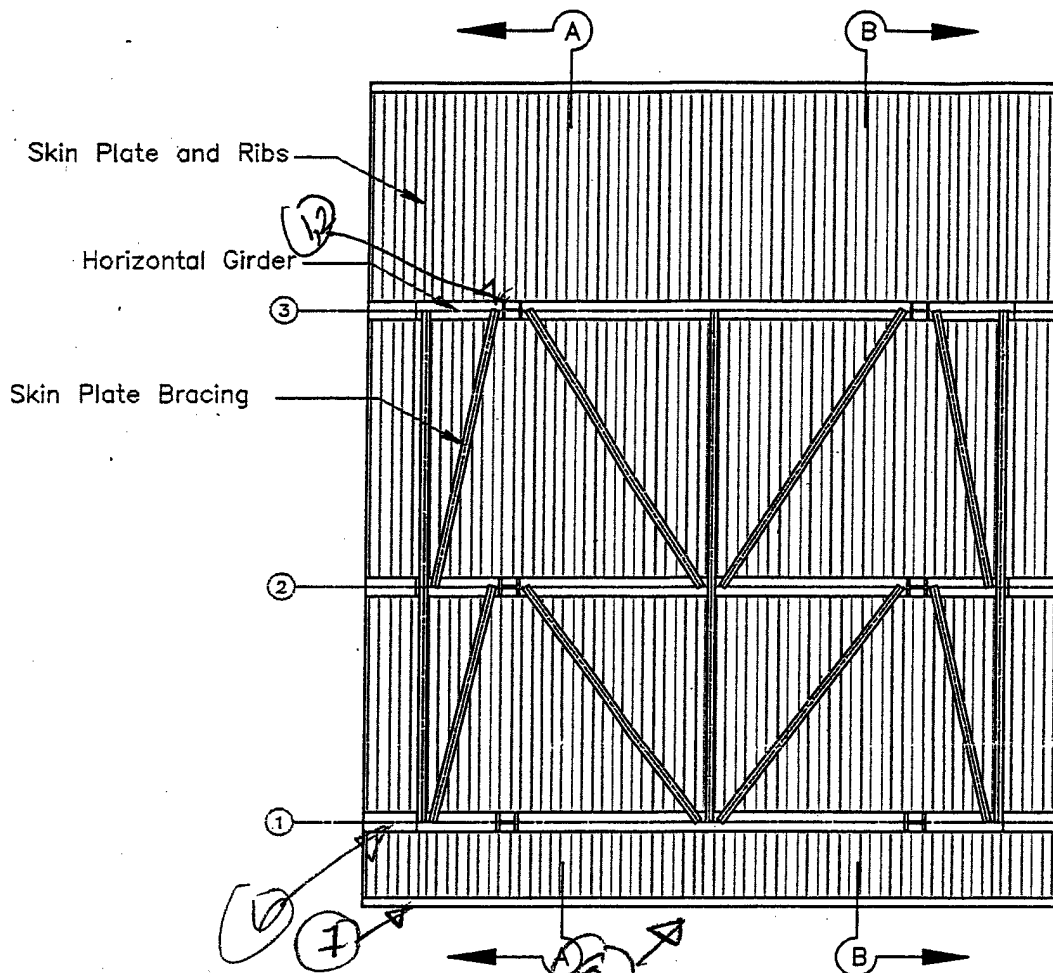
Gate No. 1 Downstream Elevation

① leaking Gate @ Bottom ②

⑧ Center @ Gate Missing concrete at Bottom Plate

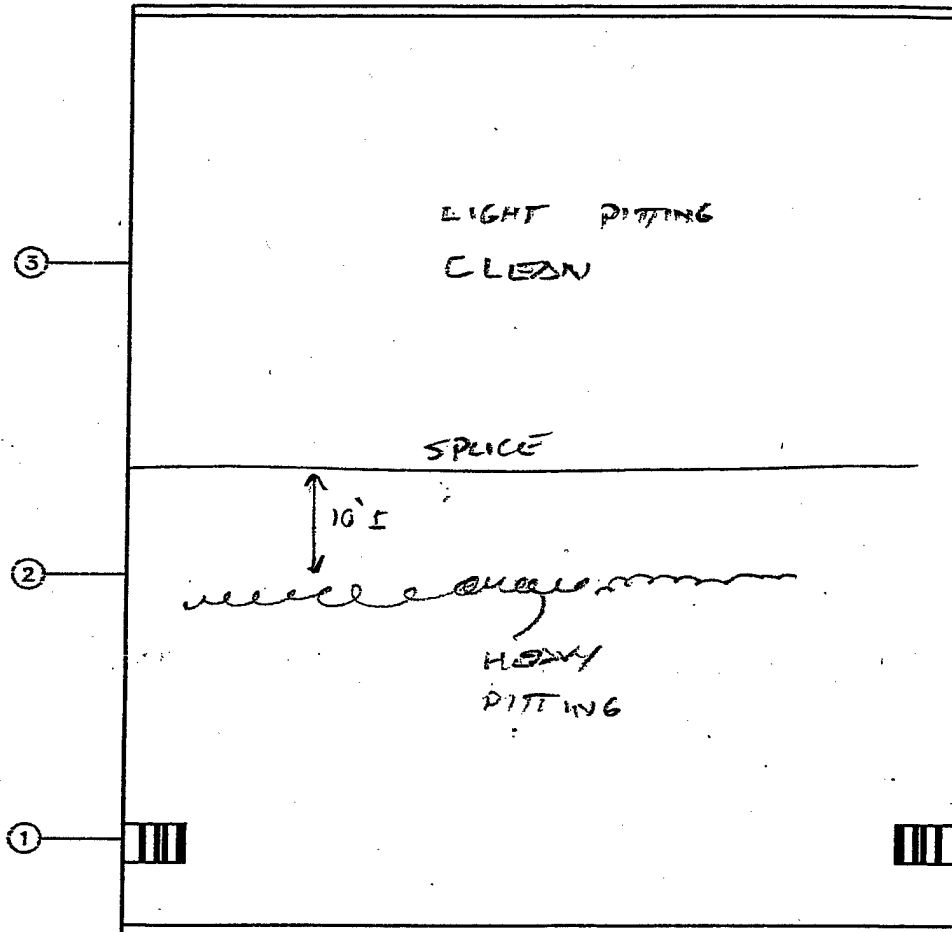
Gate No. 1 Upstream Elevation

HEAVY PITTING @ 10' BELOW SPICE / TOP OF OTHER GATES

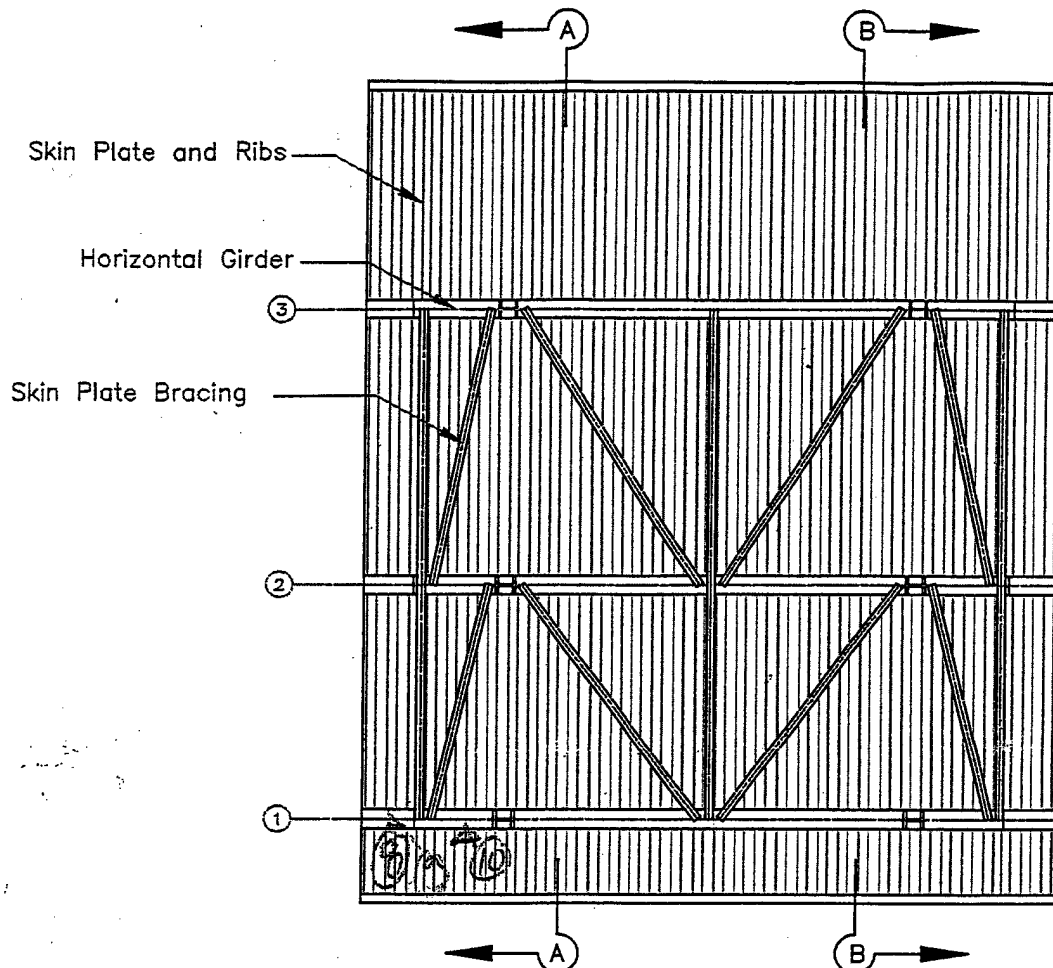
Gate No. 5 Downstream Elevation

⑦ Pending water @ bottom strut

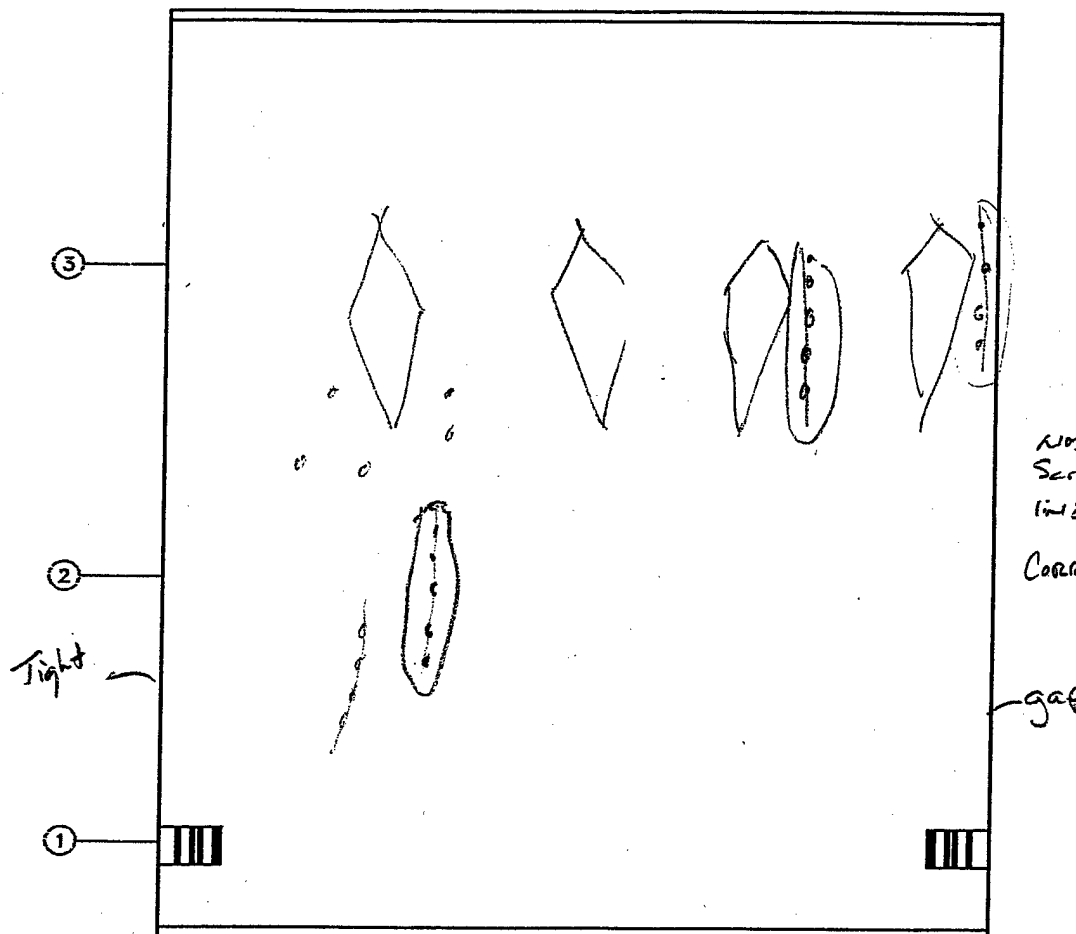
Gate No. 6 Upstream Elevation

NOTE: THERE appears to be
Scratches along Corrosion
lines.

Corr. Varies from $\frac{1}{8}$ " to $\frac{1}{4}$ "

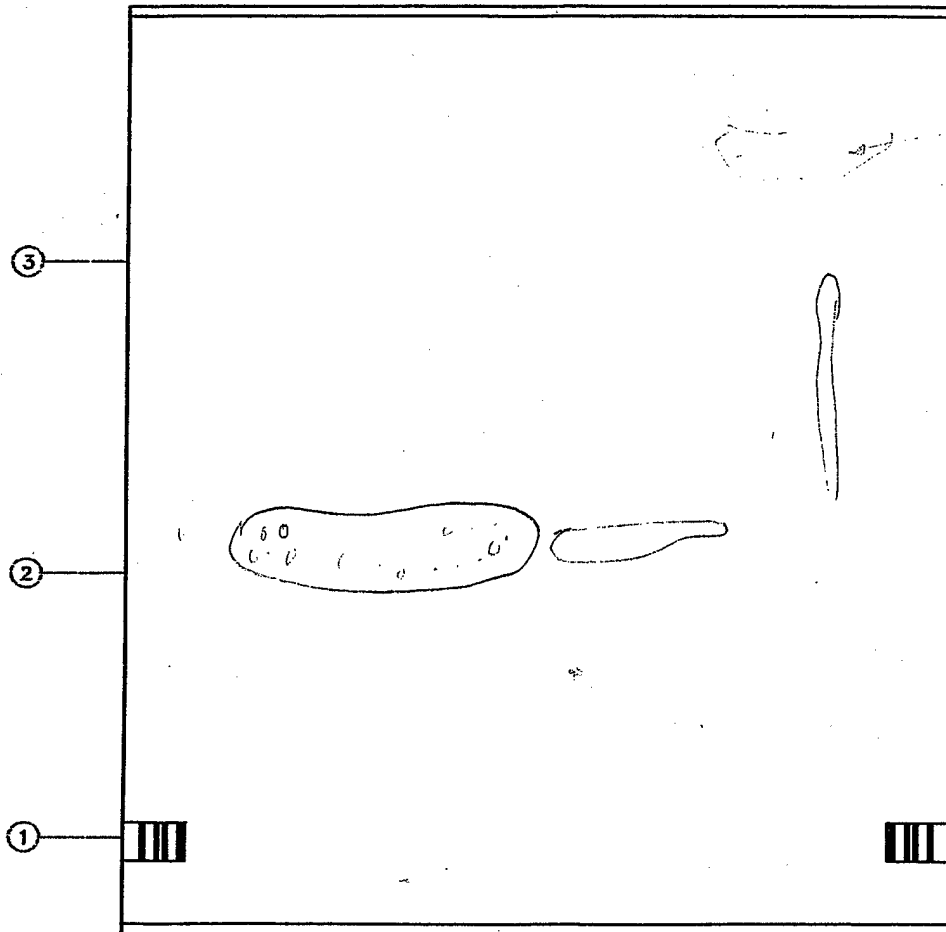
Gate No. 7 Upstream Elevation _____

- Erosion pits are in groups. $\frac{1}{2}$ - $\frac{1}{4}$ " Deep
- Cables on left side: High Vibrations
- Bottom 3rd pits are every $1\frac{1}{2}$ - 2' on ave.

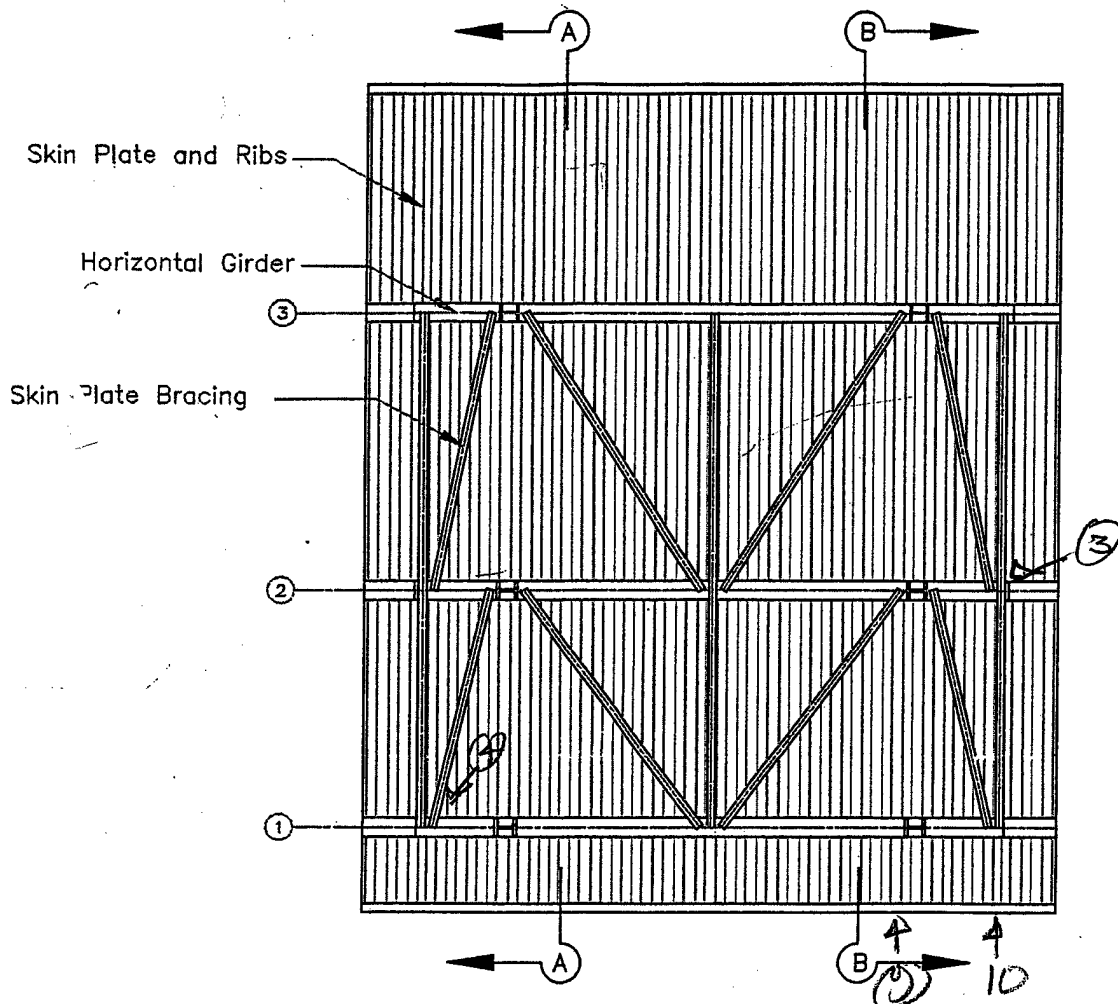
Gate No. 3 Downstream Elevation

③ Ponding in Second girder, no corrosion

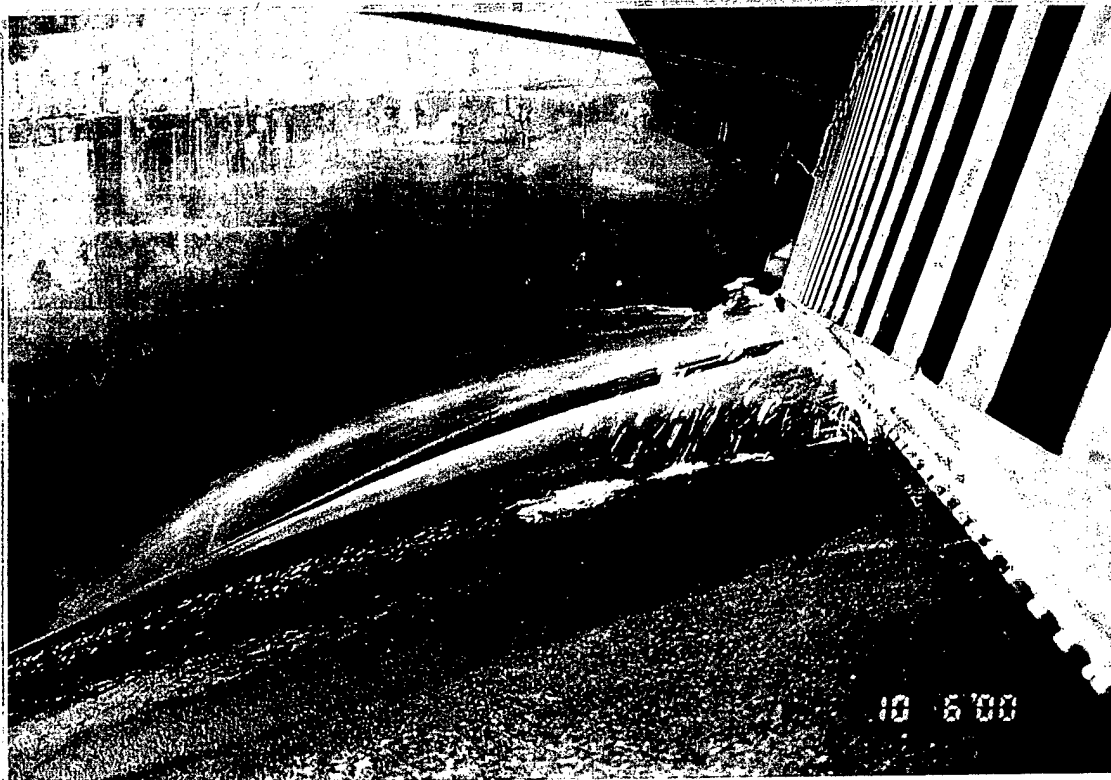
Gate 1
Leak at center construction joint in
spillway monolith.

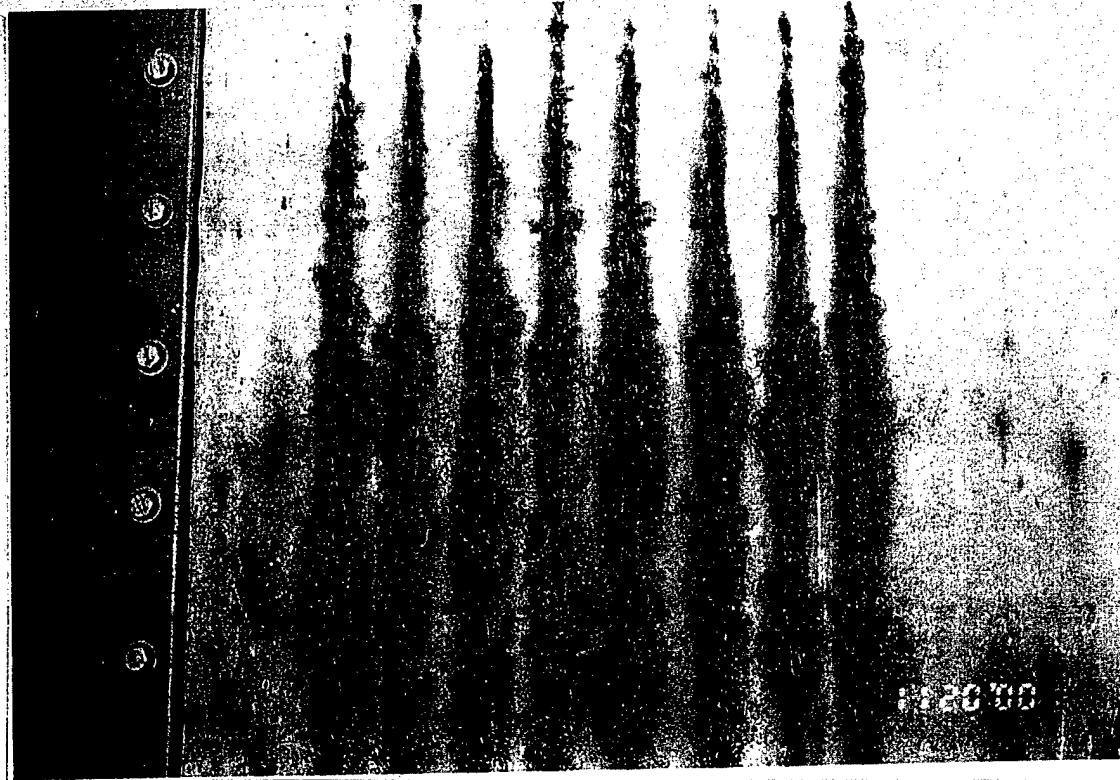
Typical skin plate condition. Light pitting near normal water surface. Note: Surface collector removed.

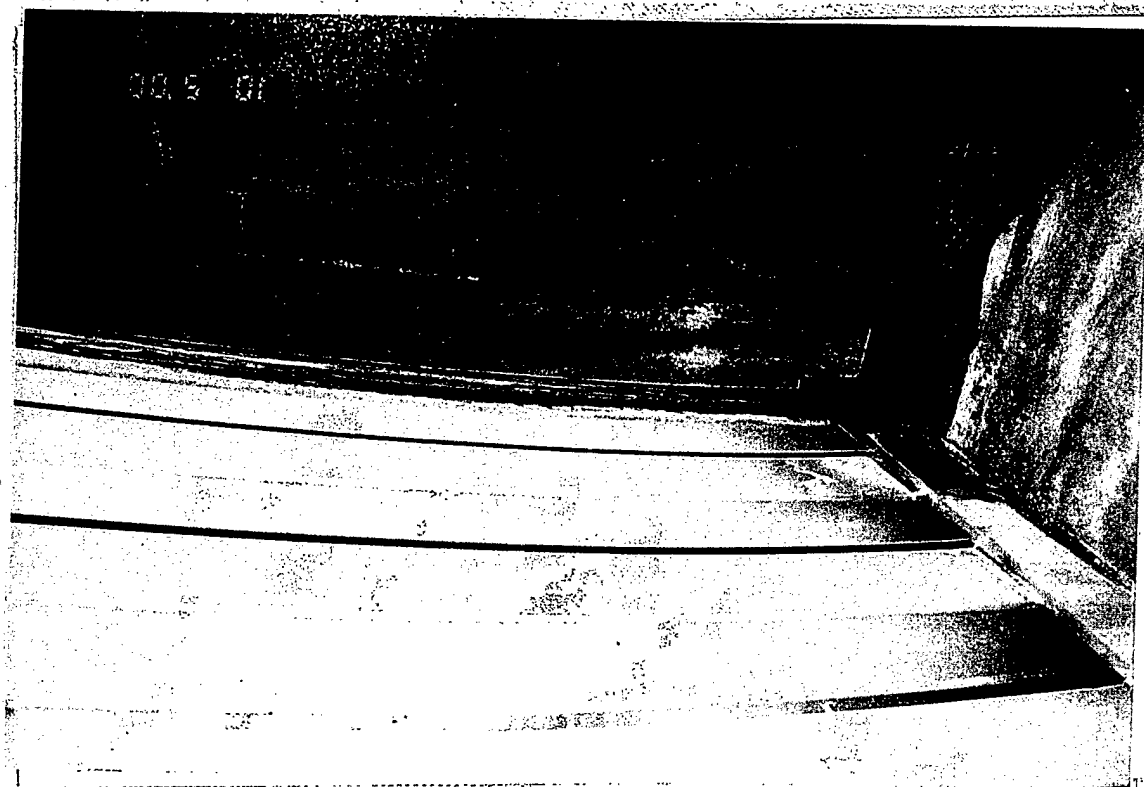
Left end, middle horizontal girder.
Peeling paint on purlins, light
corrosion.

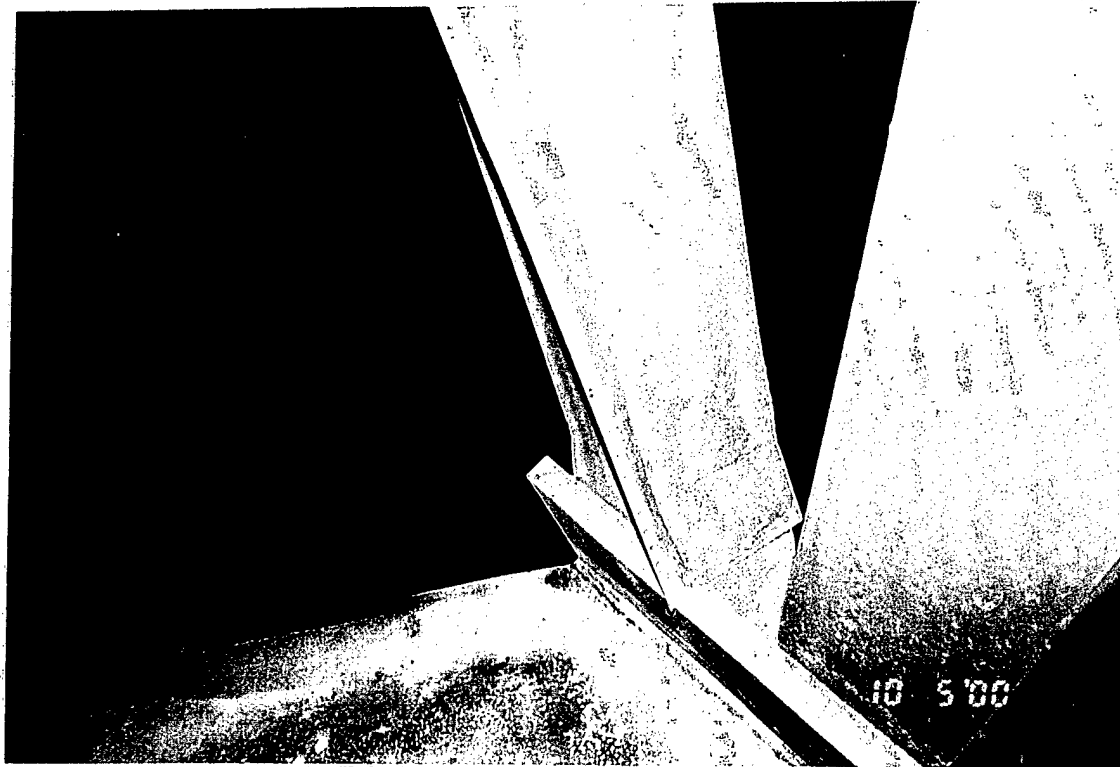
Left end, middle horizontal girder.
Peeling paint on purlins, light
corrosion.

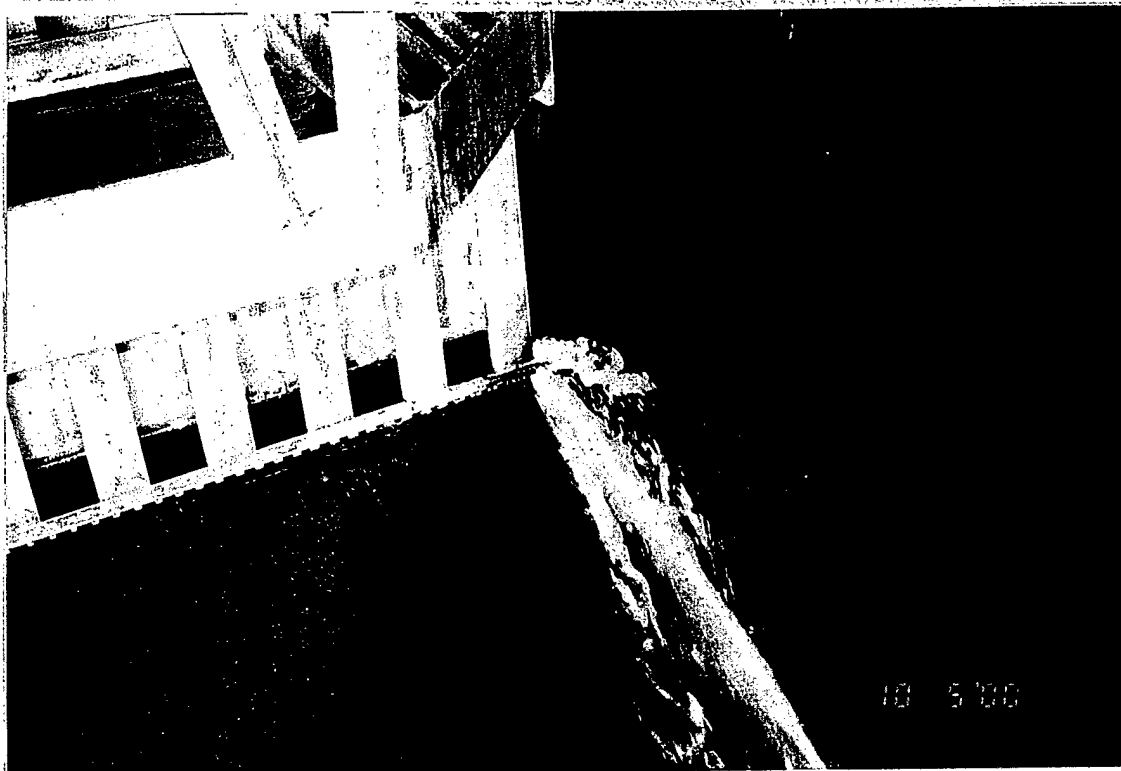
2-5

Gate 2
Bottom / side seal leak at bottom left
corner of gate.

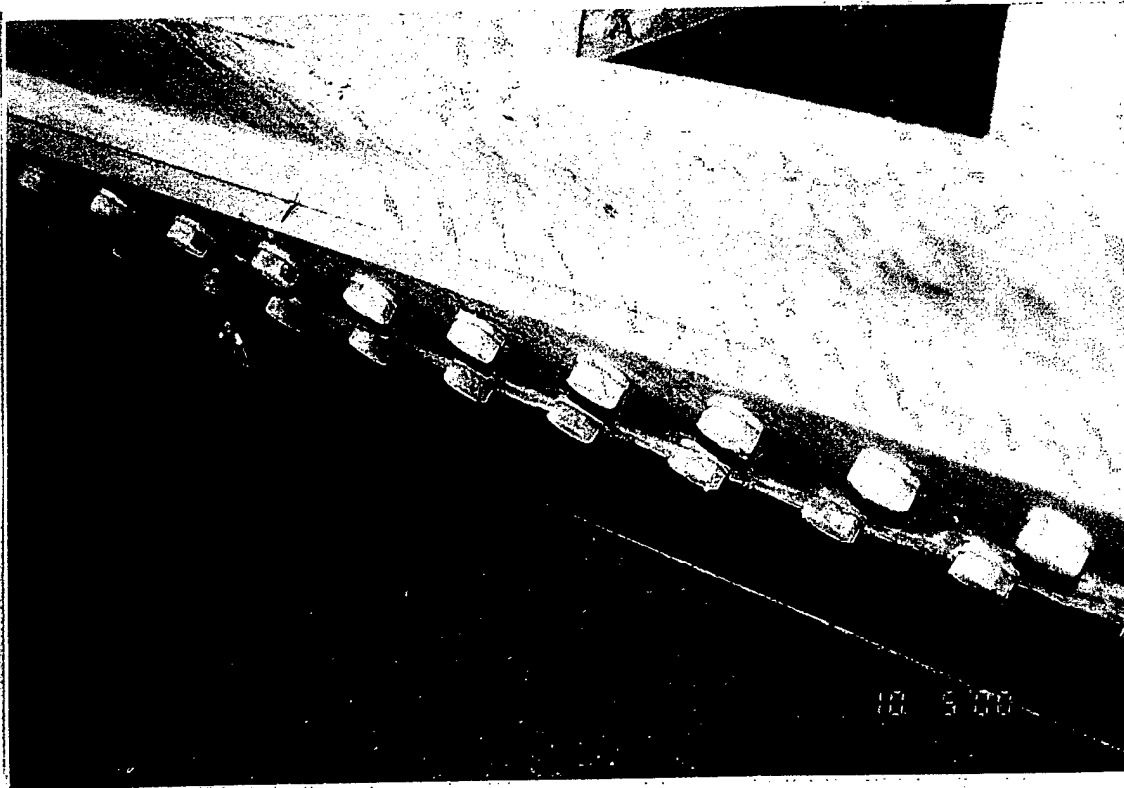
Bottom seal closure plate looking
upstream. Standing water between
closure plate, purlin webs and
skinplate. Typical. Leak at center
const. joint in spillway monolith.

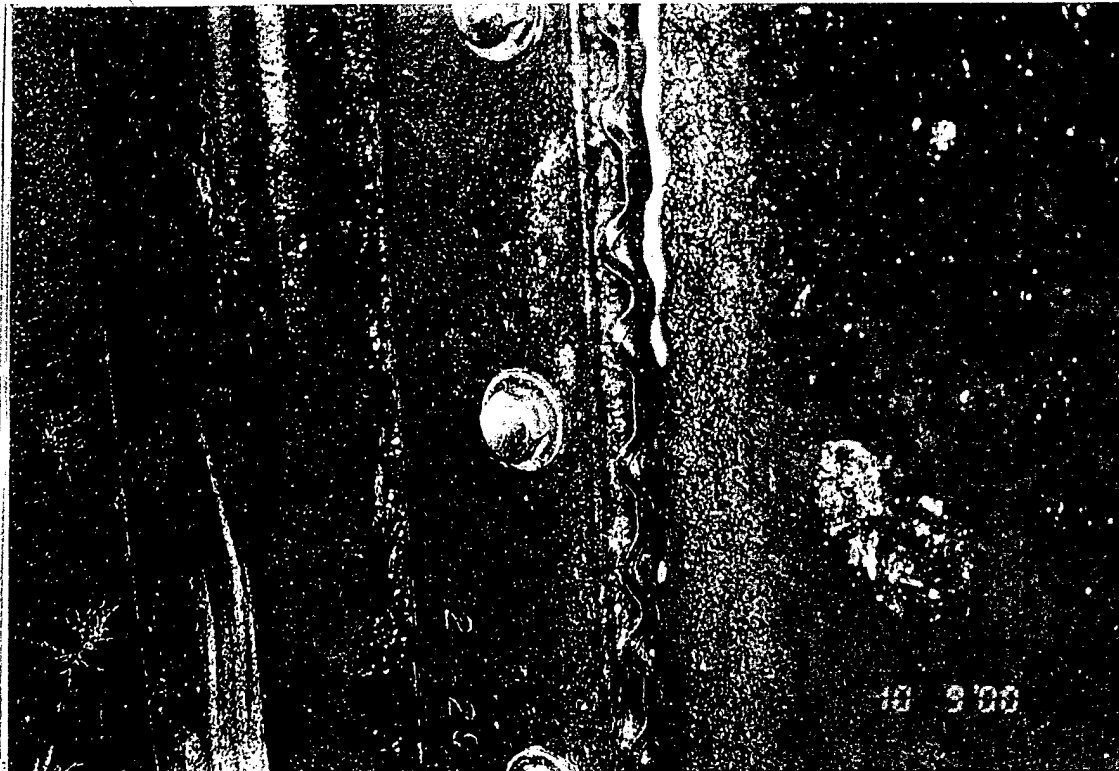
Note: Excellent condition of stainless steel U-bolts.

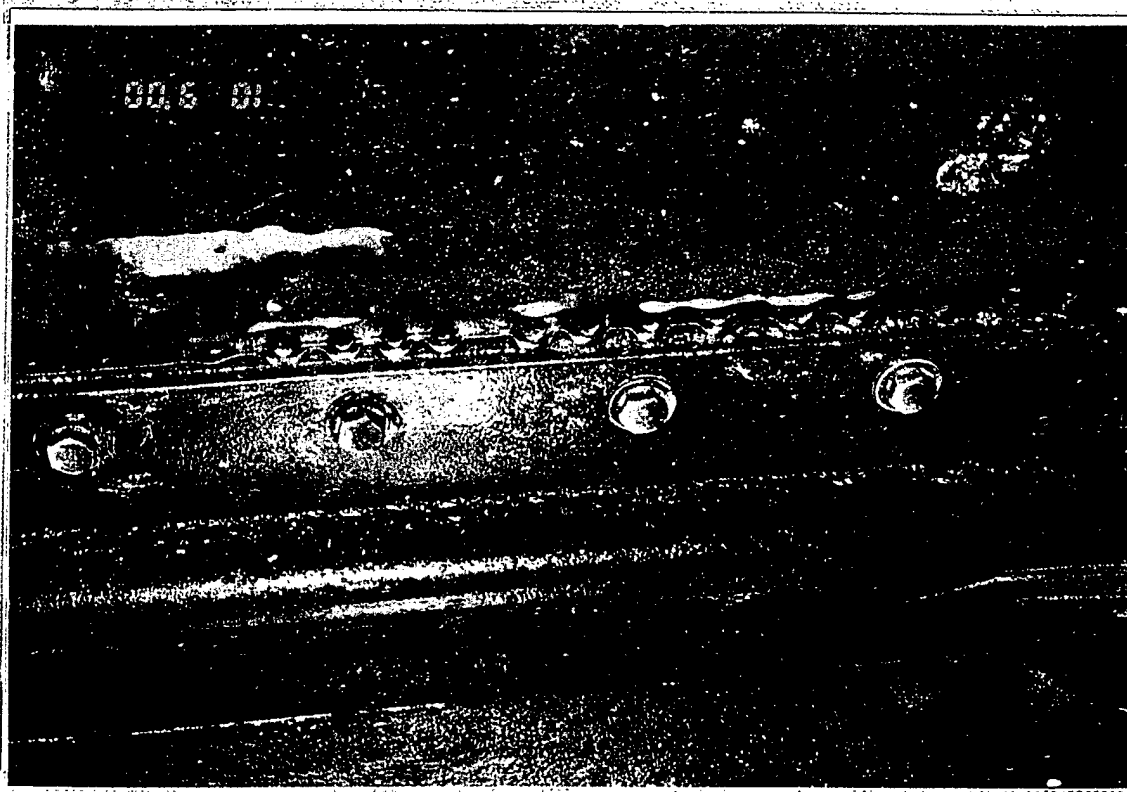
Gate 2
Upstream side of left side seal. Light corrosion and pitting on skin plate.

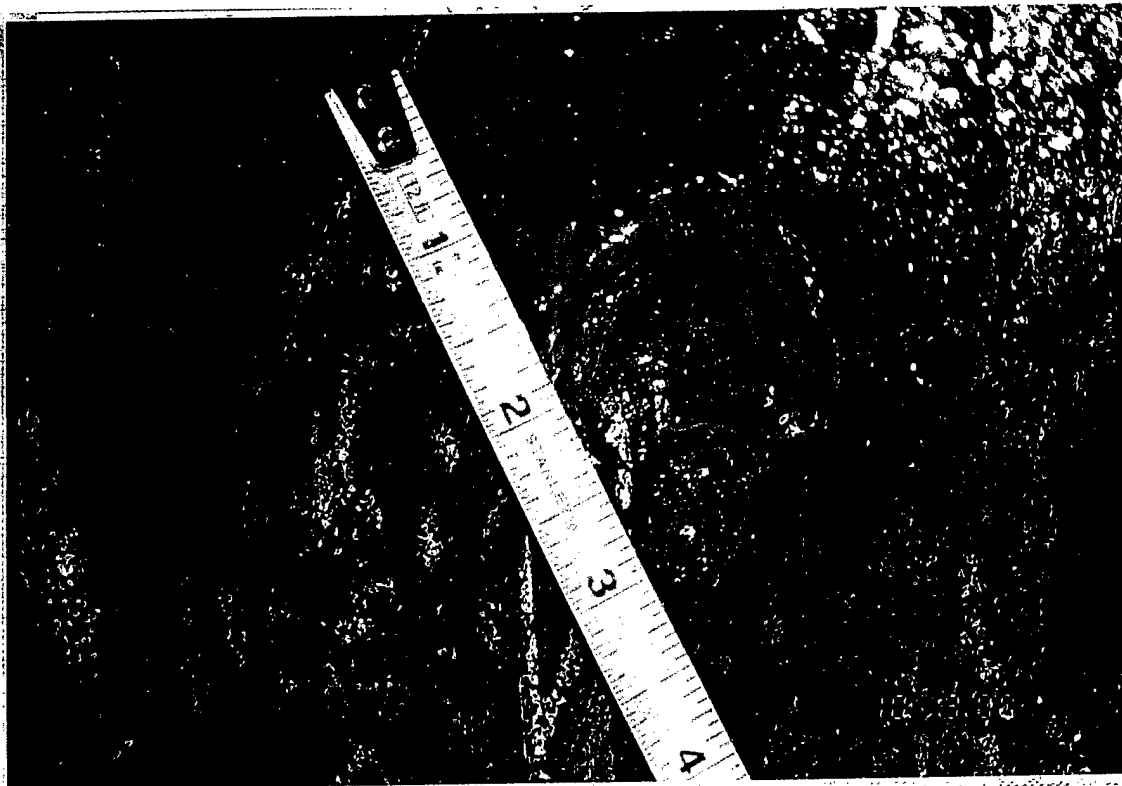
Gate 2
Upstream side of left side seal. Light corrosion and pitting on skin plate.

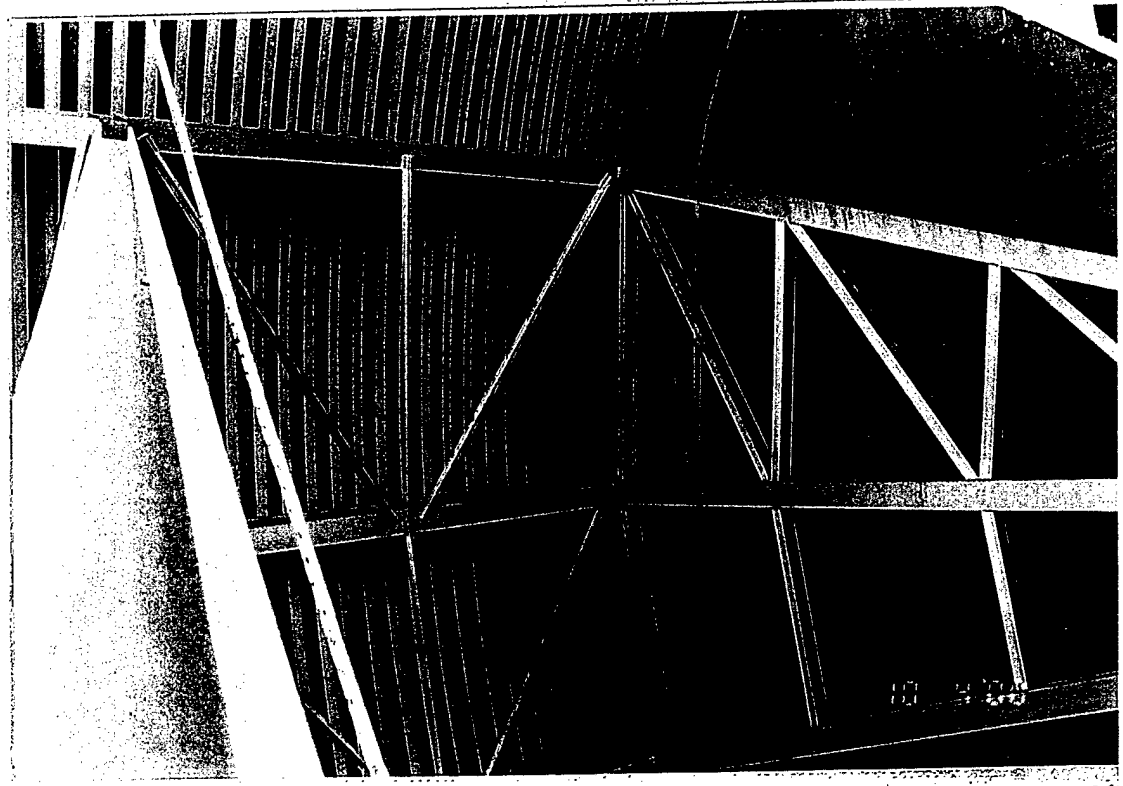
Gate 3
Right trunnion and yoke looking
downstream. Light corrosion on
trunnion.

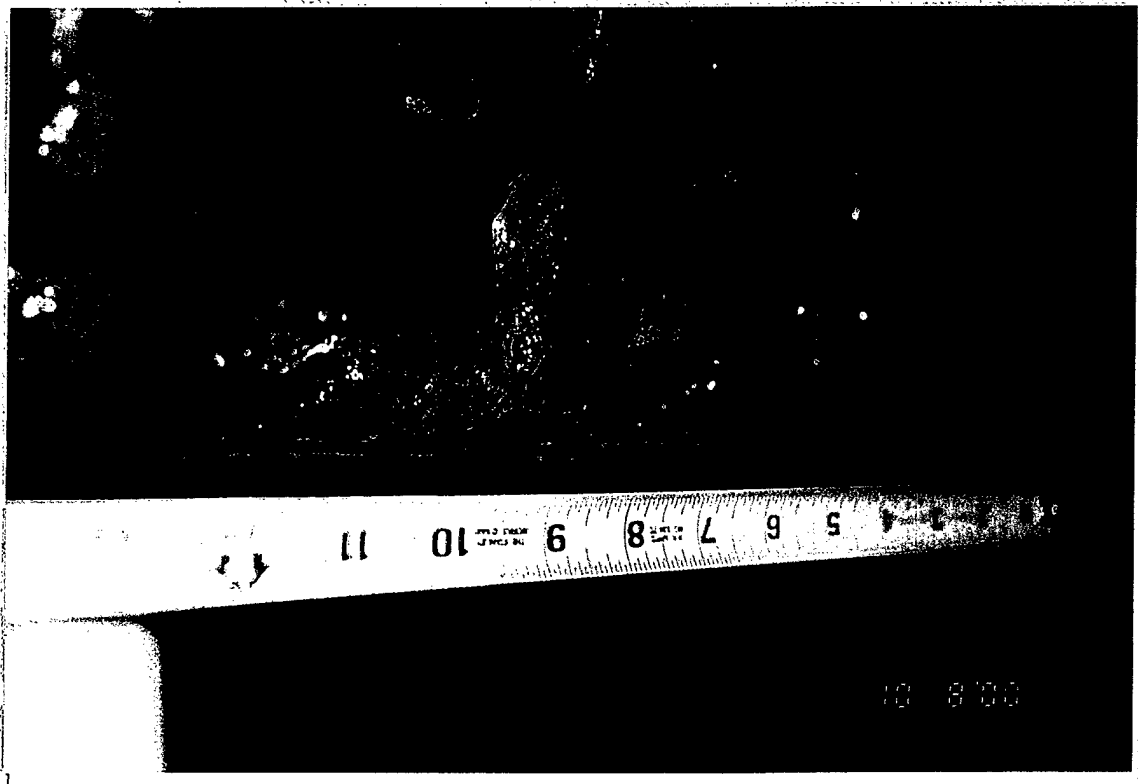
Upstream side of skin plate at
bottom seal. Light to moderate
corrosion of skin plate, typical.

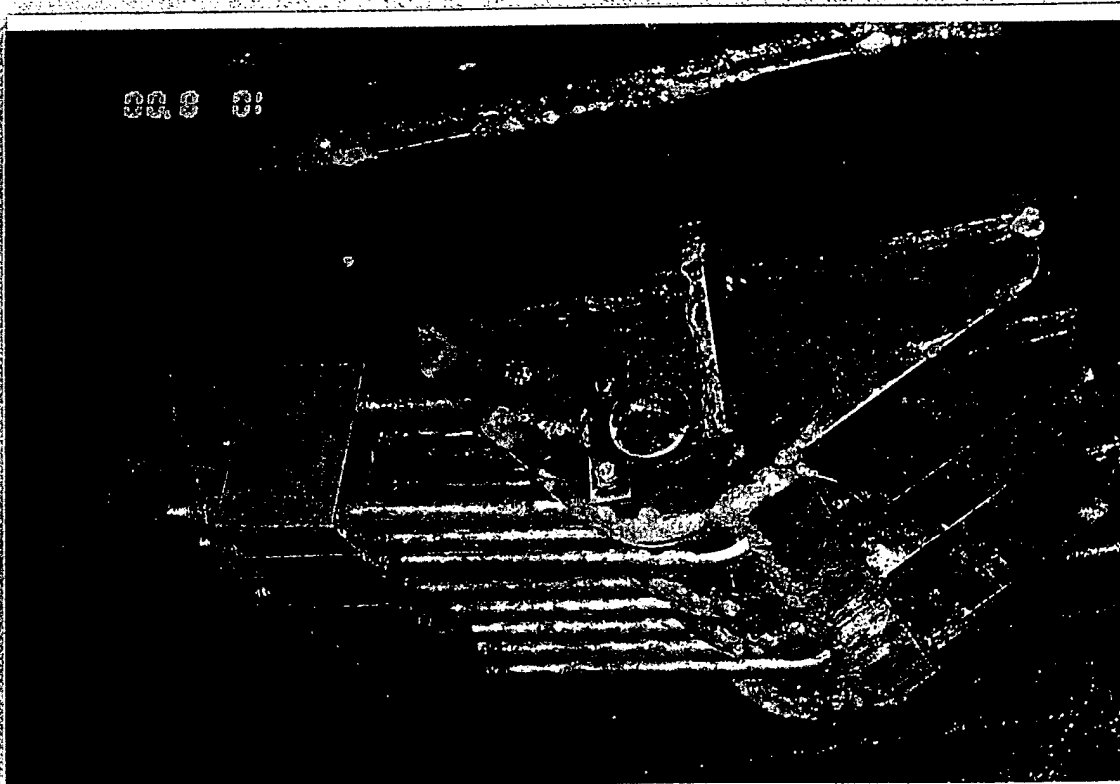
Left side hoist connection. Light corrosion on lifting lugs and plates.
Note: excellent condition of stainless steel U-bolts.

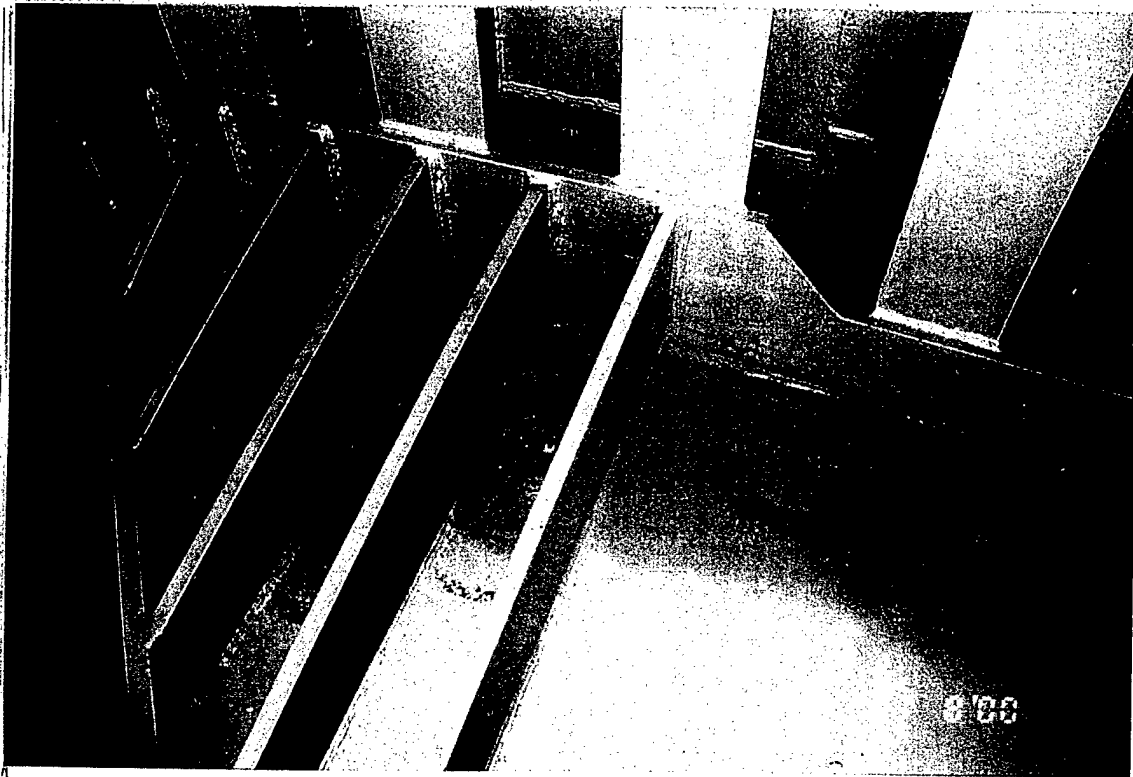
Skin plate leak after removal of paint
blister.

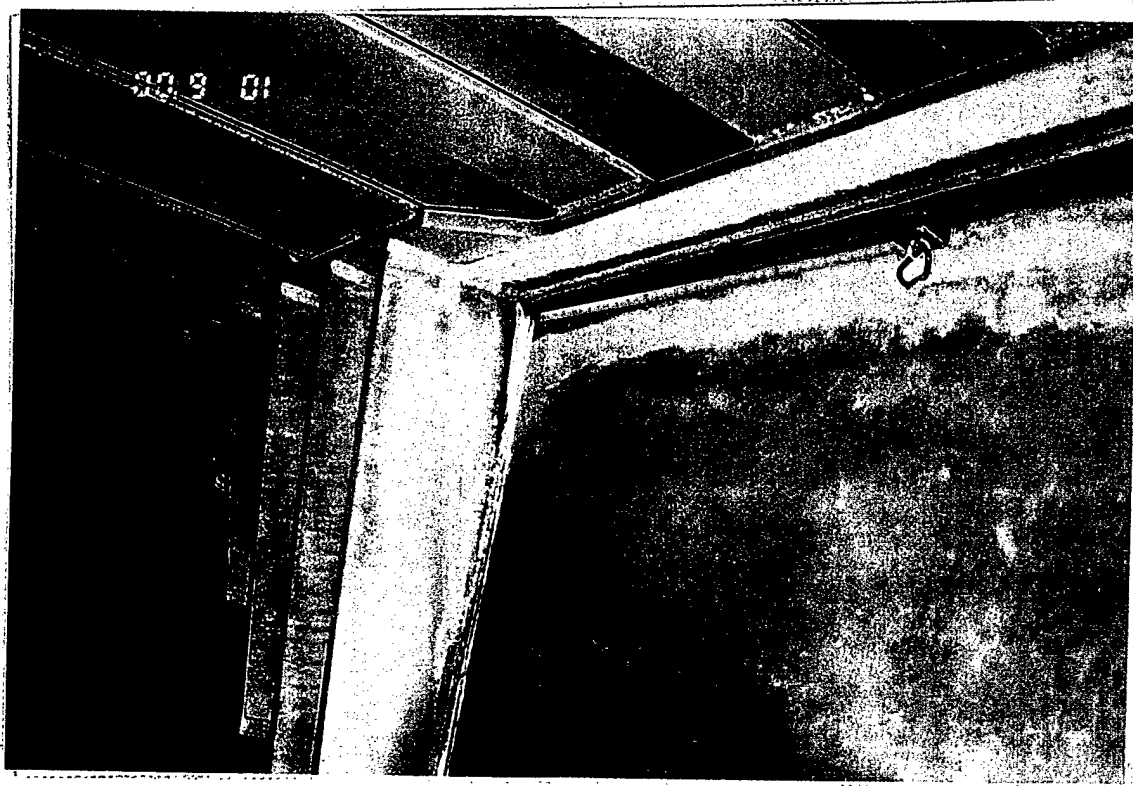
Gate 6
Right frame, bottom radial strut.
Standing water at upstream end of
strut due to inadequate drainage.

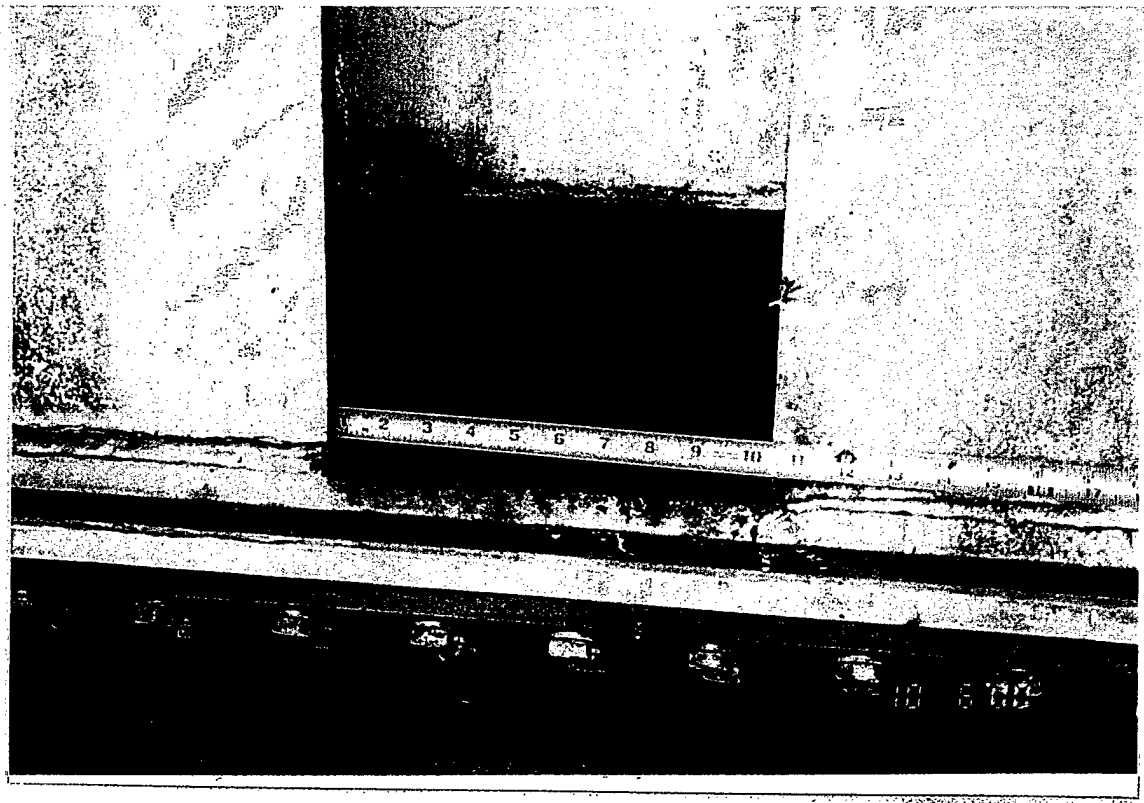
Left frame, bottom radial strut.
Evidence of standing water at
upstream end of strut due to
inadequate drainage. Light
corrosion.

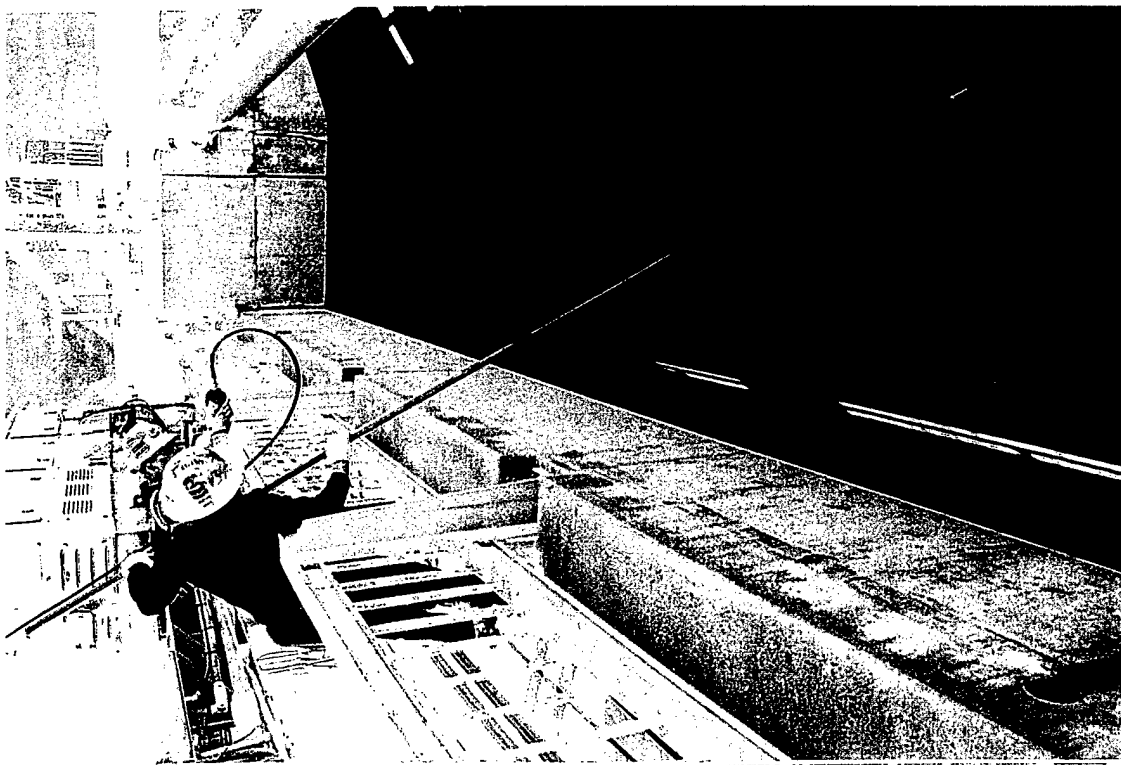
Lower Gate 6
Granite Waterblasting of skin plate, typical.
Dam

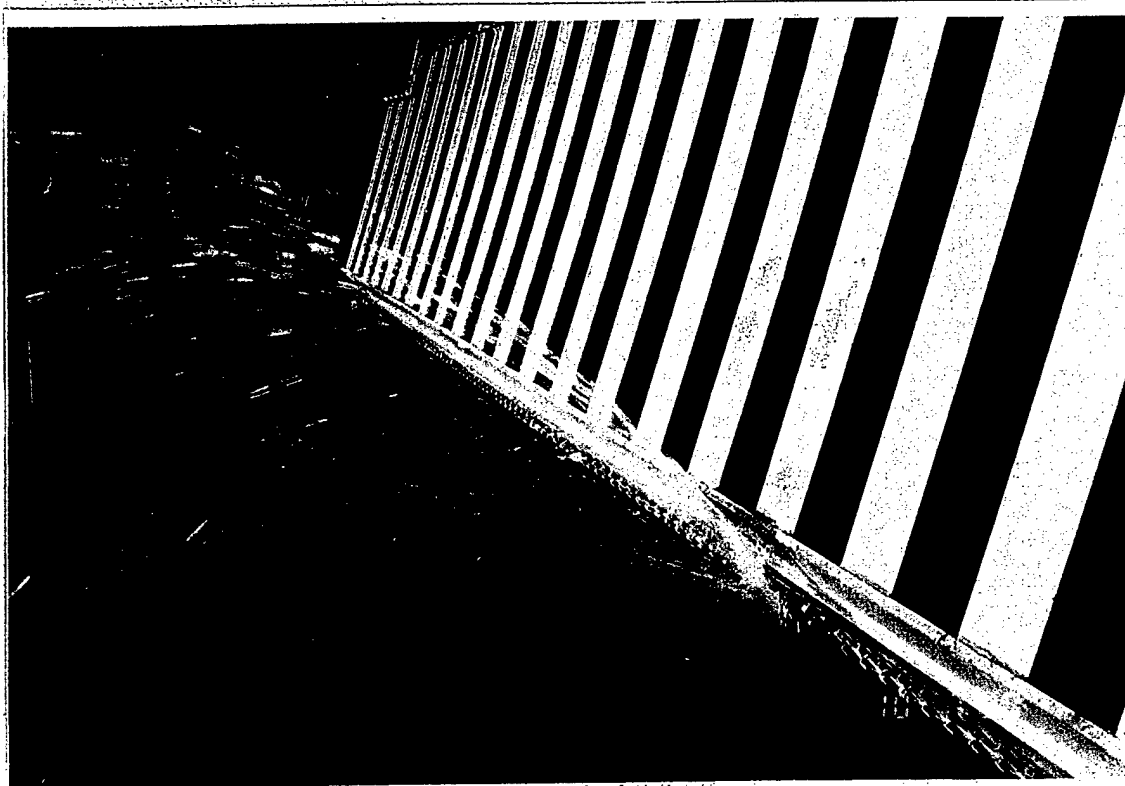
Gate 7
Bottom seal closure plate looking
upstream. Standing water between
closure plate, purlin webs and
skinplate. Typical.

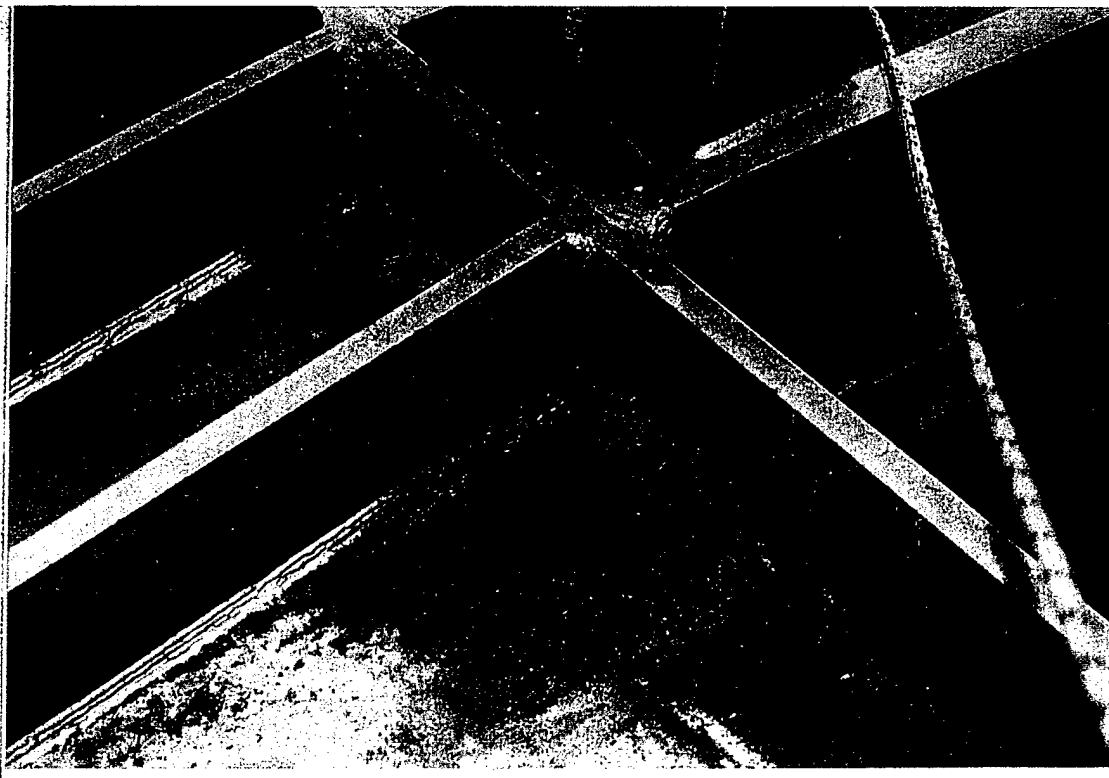
Typical wear plate condition. Light
grooves due to cable wear, light to
moderate corrosion.

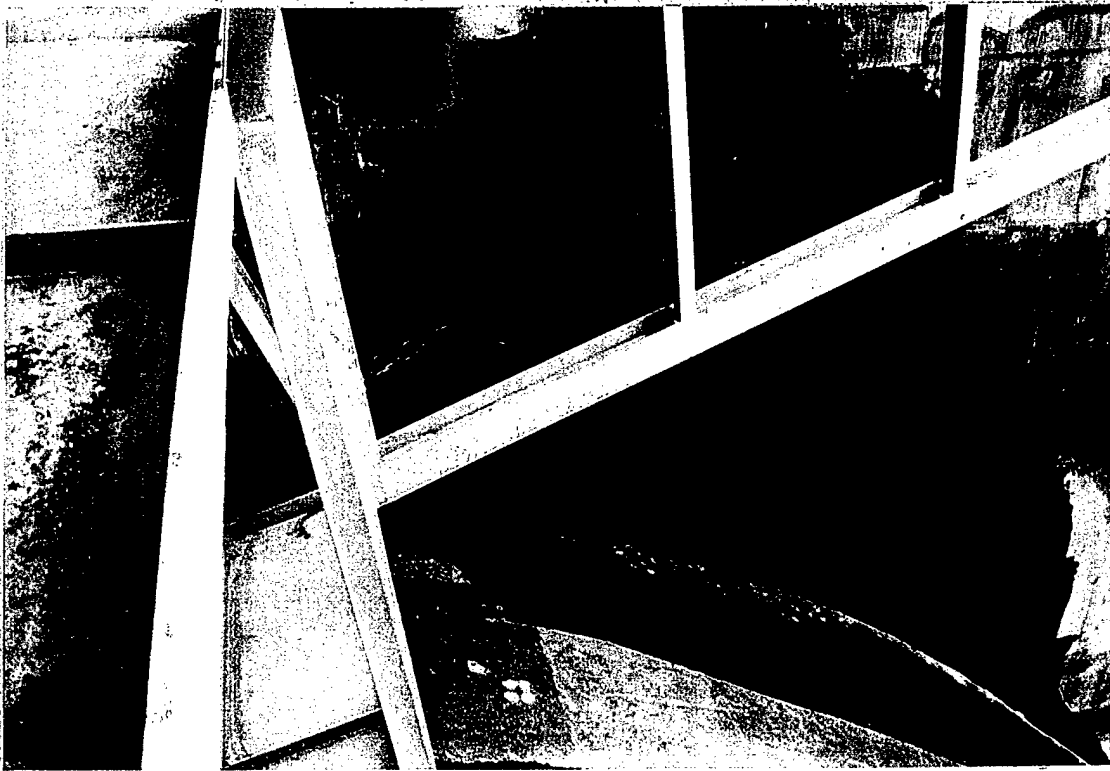
Middle horizontal girder at
connection to middle right strut.
Debris and evidence of standing
water, light corrosion.
